# GEOTECHNICAL PROPERTIES AND CHARACTERISTICS OF METAMORPHIC ROCK MASS ON POBOYA GOLD MINE

Sriyati Ramadhani<sup>1</sup>, \*Ahmad Rifa'i<sup>2</sup>, Kabul Basah Suryolelono<sup>3</sup>, Wahyu Wilopo<sup>4</sup>

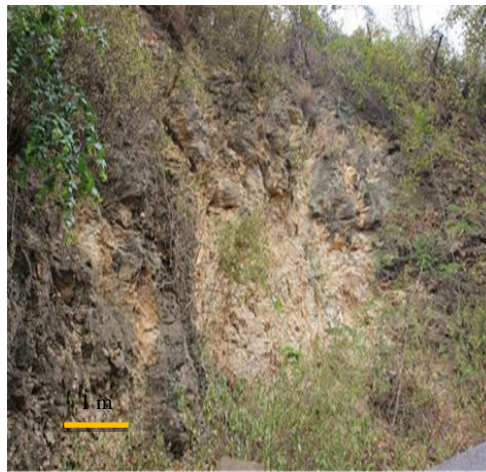
Color	Density Concentrations		
	0,00 - 2,40		
	2,40 - 4,80		
	4,80 - 7,20		
	7,20 - 9,60		
	9,60 - 12,00		
	12,00 - 14,40		
	14,40 - 16,80		
	16,80 - 19,20		
	19,20 - 21,60		
	21,60 - 24,00		
<b>Contour Data</b> Pole Vectors			
<b>Maximum Density</b> 23.34%			
<b>Contour Distribution</b> Fisher			
<b>Counting Circle Size</b> 1.0%			
Color	Dip	Dip Direction	Label
<b>User Planes</b>			
1	84	133	
<b>Plot Mode</b> Pole Vectors			
<b>Vector Count</b> 11 (11 Entries)			
<b>Hemisphere</b> Lower			
<b>Projection</b> Equal Angle

**Figure 4.** Discontinuity pattern in location 1 *gneiss* lithology: Discontinuity view on field, b) Plot of discontinuity point.

*roughness* parameter is predominantly slightly rough, and *weathering* condition is predominantly highly weathered, grand water condition is mostly dry and dominantly with none *infilling*. Result of discontinuity point plot at location 1 of

*gneiss* lithology that there is a set discontinuity as shown in Figure 4. It obtained from a set 1 of *gneiss* that the discontinuity orientations show the value of *dip* of 84° with the value of *dip direction* N133°E.

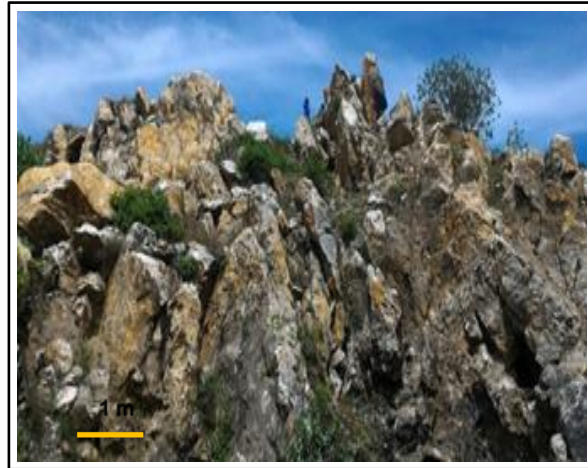
**Figure 5.** Discontinuity patten in location 2schistlitology: Discontinuity view on field, b) Plot of discontinuity point.

Condition of roughness parameter is predominantly *slightly rough*, and *weathering* condition is mostly *highly weathered*, ground water condition is predominantly *dry* and dominantly with none infilling. Result of discontinuity point plot at location 2 of *schist* lithology that there are two sets

of discontinuities as shown in Figure 5. From the set 1 of *schist*, it obtained the discontinuity orientation which shows *dip* value of 51° with *dip direction* value of N119°E. From the set 2 of *schist*, it obtained the discontinuity orientation which shows *dip* value of 74° with *dip direction* value of N307°E.

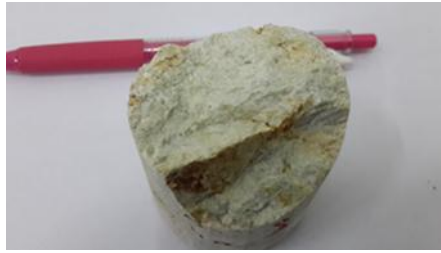
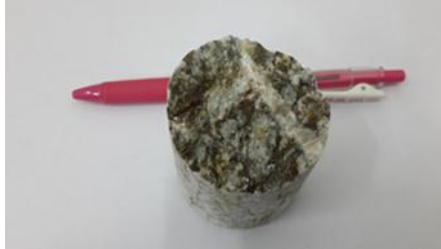
**Figure 6** Types of rock for laboratory test:  
 a) *gneiss*, b) *schist*

*schist* lithologies derived from the study site. The taken sample rocks are in form of chunks. Chunks of rock used for laboratory tests are in form of weathered rocks as shown in Figure 6.
